## **EXTERNAL FIRE EXPOSURE TO ROOF TEST REPORT No EUI-24-RT4-0000503**

**Test Standard:** **CEN/TS 1187:2012** – Test methods for external fire exposure to roofs  
Test 4 – Method with two stages incorporating burning brands, wind and supplementary radiant heat

**Product:** The roof system consists of a resin-bound stone decking installed on pedestals, which are positioned above rigid foam insulation layers. This rigid foam insulation layers are placed over a waterproofing membrane, which was applied on top of an OSB deck.  
Referenced: Resin Bound Gravel System

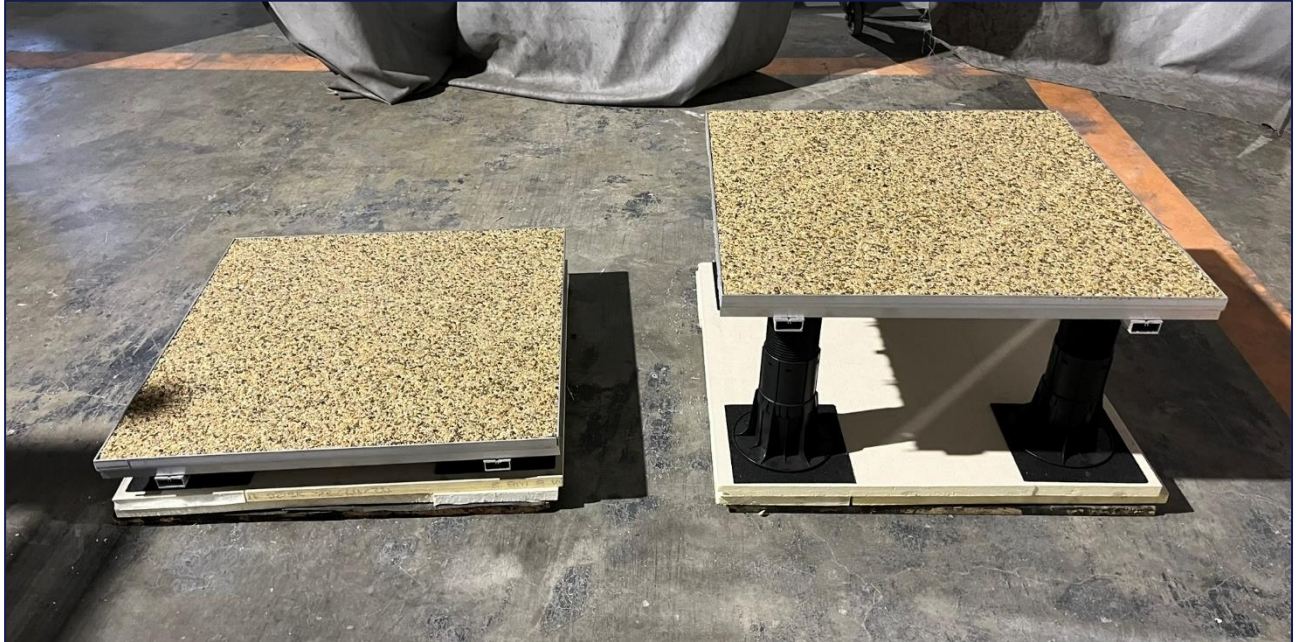
Figure 2: Overall view of the tested samples (180 mm and 495 mm)

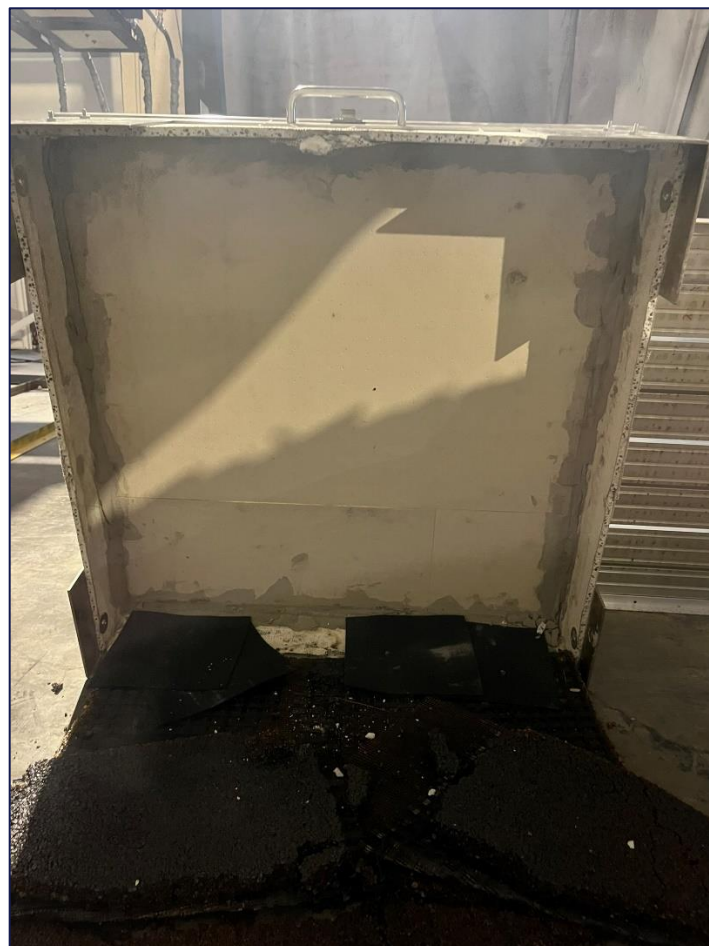
Figure 3: Air seal (mortar sealant) performed at the top of the rigid insulation foam.

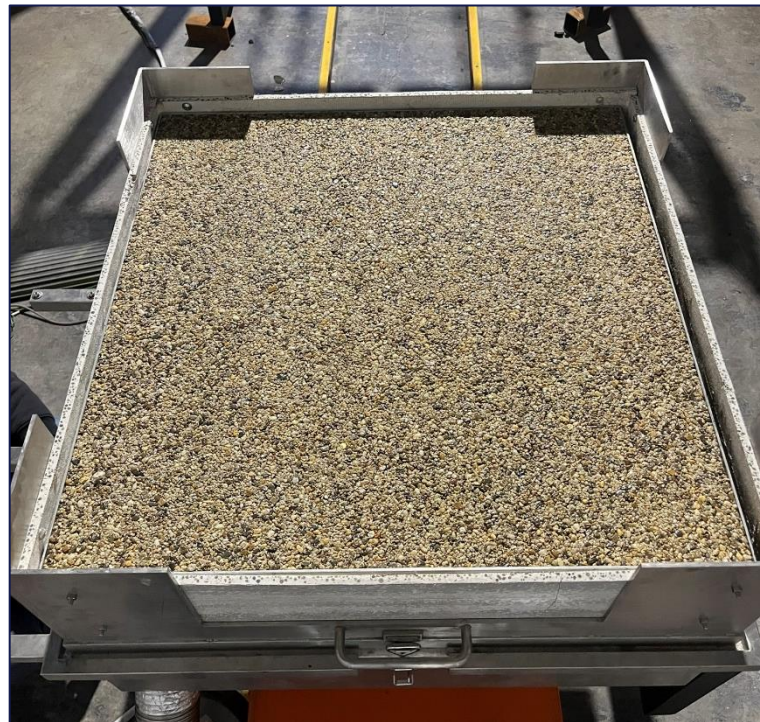
Figure 4: Top view of the sample prior the testing.

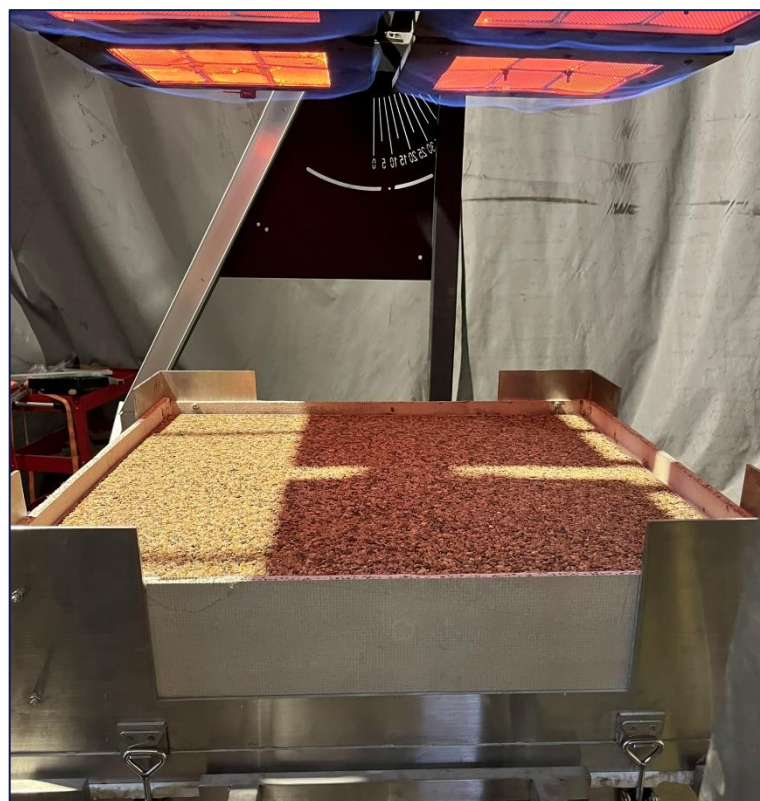
Figure 5: Sample configuration during testing.

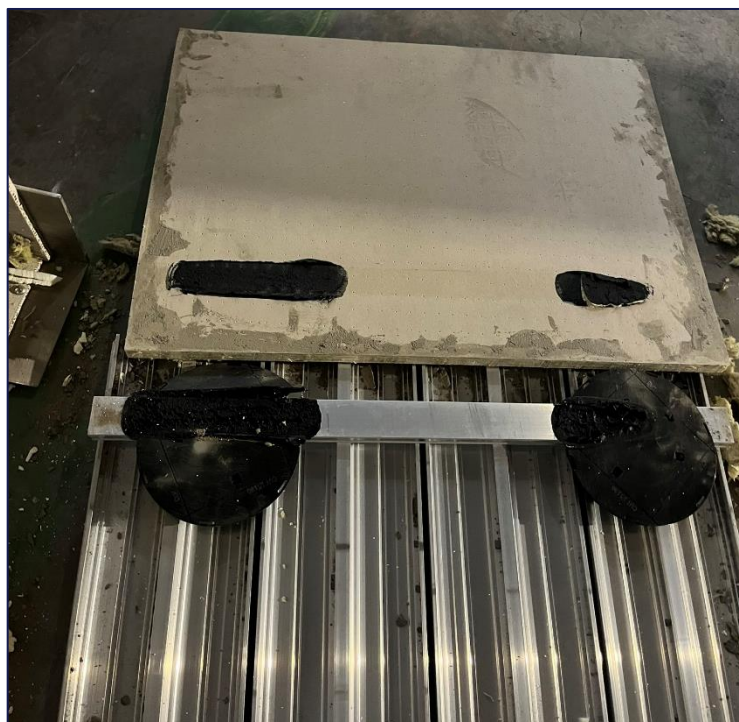
Figure 7: Damage investigation – Sample C – Pedestal and rigid foam insulation.

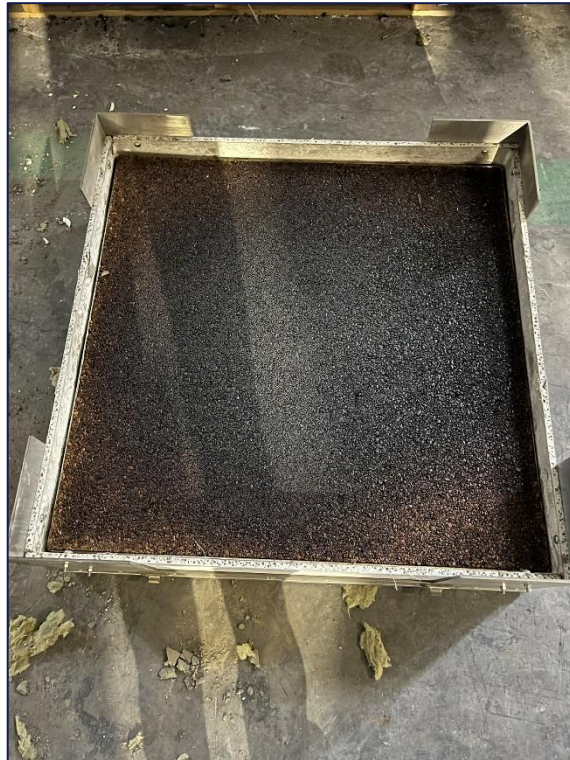
Figure 8: Damage investigation – Sample E – After 60 min of radiant heat exposure.

Test 3	
Time (min)	Observation
00 min 00 s	Sample exposed to radiant heat.
06 min 00 s	No sustained flaming observed during or after the application of the burning brand.
15 min 00 s	Deformation noticed on the surface of the specimen.
26 min 00 s	Dark discoloration noticed on the surface of the specimen. Small spalling noticed.
29 min 30 s	No smoke or penetration observed on the underside of the specimen.
45 min 00 s	N.N.T.R.
59 min 30 s	N.N.T.R.
60 min 00 s	End of the test.

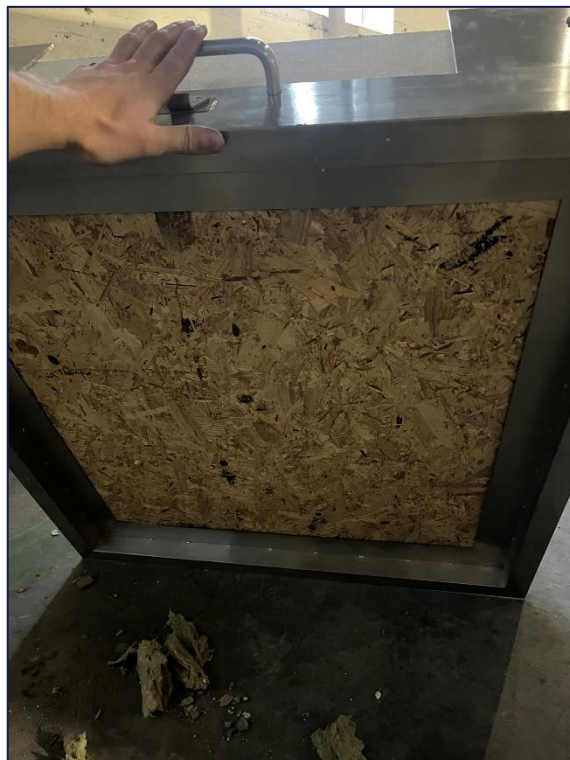
Figure 9: Damage investigation – Sample C – Non-exposed side of the specimen.

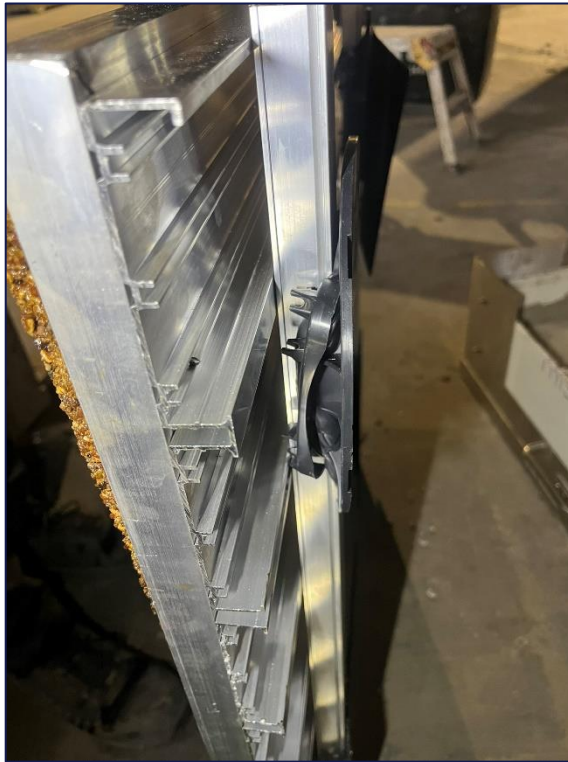
Figure 10: Damage investigation – Sample E – Pedestal.

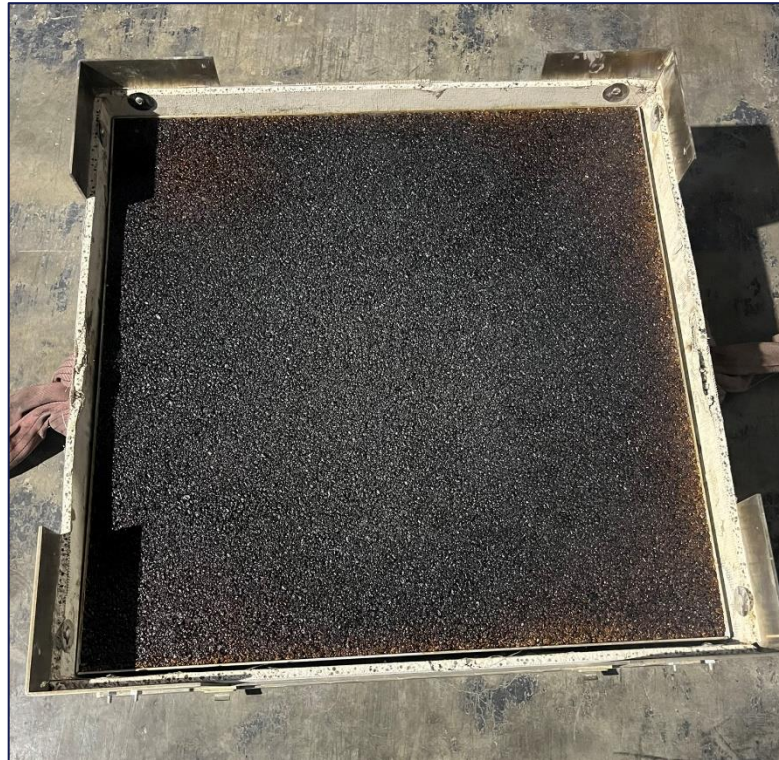
Figure 11: Damage investigation – Sample F – After 60 min of radiant heat exposure.

Test 4	
Time (min)	Observation
00 min 00 s	Sample exposed to radiant heat.
06 min 00 s	No sustained flaming observed during or after the application of the burning brand.
15 min 00 s	Deformation noticed on the surface of the specimen.
26 min 00 s	Dark discoloration noticed on the surface of the specimen.
29 min 30 s	No smoke or penetration observed on the underside of the specimen.
45 min 00 s	N.N.T.R.
59 min 30 s	No smoke or penetration observed on the underside of the specimen.
60 min 00 s	End of the test.

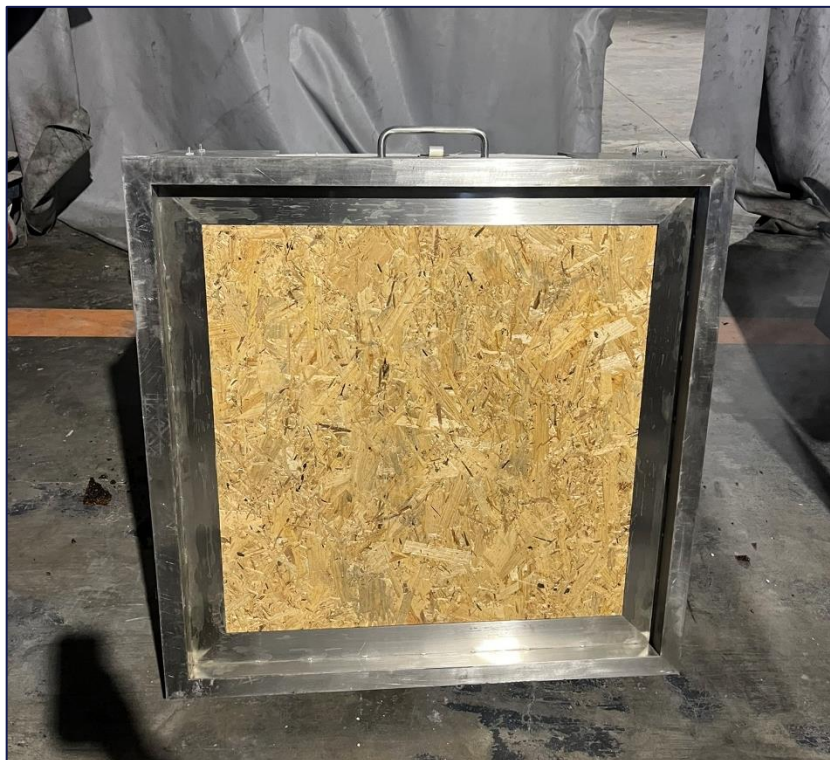
Figure 12: Damage investigation – Sample F – Non-exposed side of the specimen.

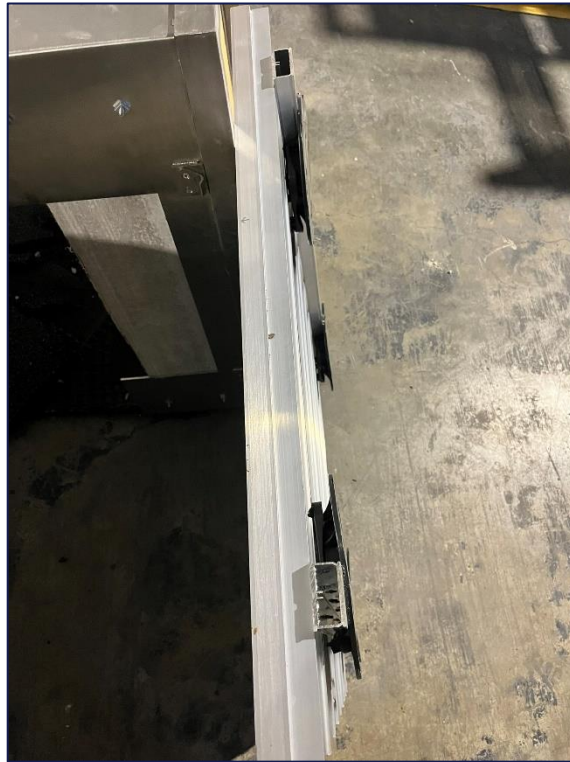
Figure 13: Damage investigation – Sample F – Pedestal.

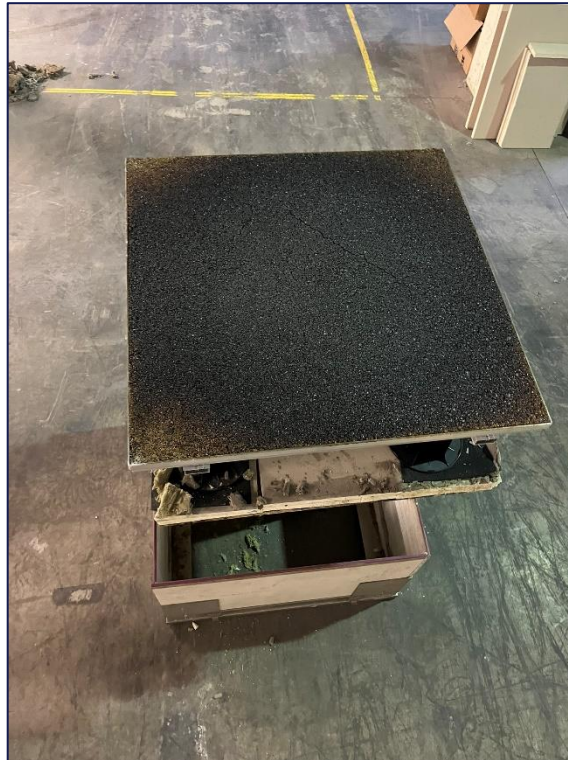
Figure 14: Damage investigation – Sample G – After 60 min of radiant heat exposure.

Test 5	
Time (min)	Observation
00 min 00 s	Sample exposed to radiant heat.
06 min 00 s	No sustained flaming observed during or after the application of the burning brand.
07 min 00 s	Deformation noticed on the surface of the specimen.
23 min 00 s	Dark discoloration noticed on the surface of the specimen.
29 min 30 s	No smoke or penetration observed on the underside of the specimen.
45 min 00 s	N.N.T.R.
59 min 30 s	No smoke or penetration observed on the underside of the specimen.
60 min 00 s	End of the test.

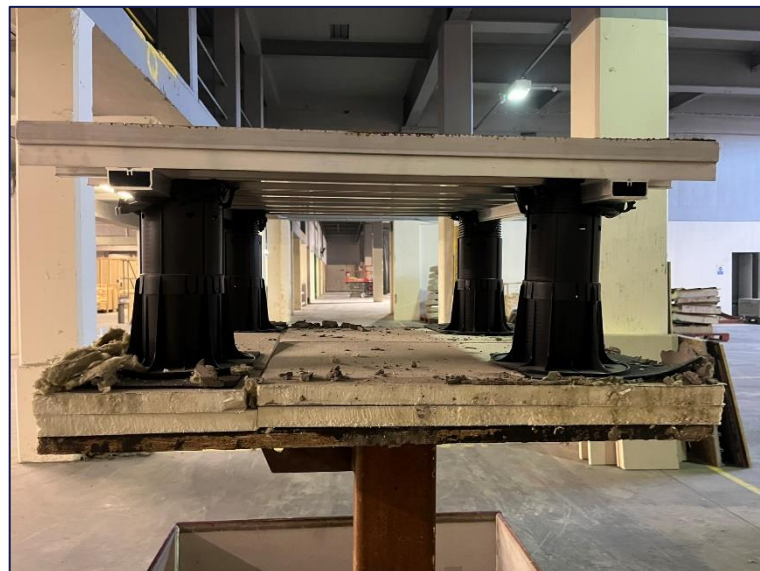
Figure 15: Damage investigation – Sample G – Side view.

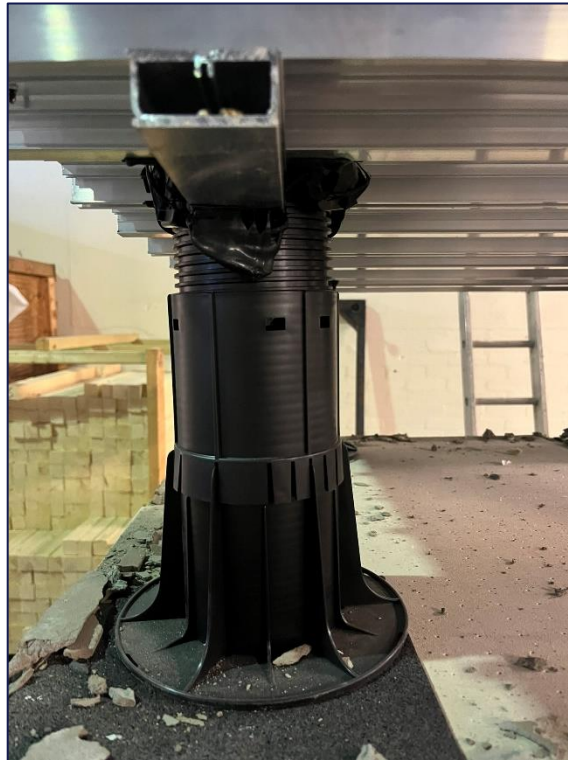
Figure 16: Damage investigation – Sample G – Pedestal.
